JOINT HIGHWAY RESEARCH PROJECT

JHRP-75-15

USE OF PRECAST-PRESTRESSED CONCRETE FOR BRIDGE DECKS

July 30, 1975
Revised Dec. 1976
Project: C-36-56N
File: 7-4-14

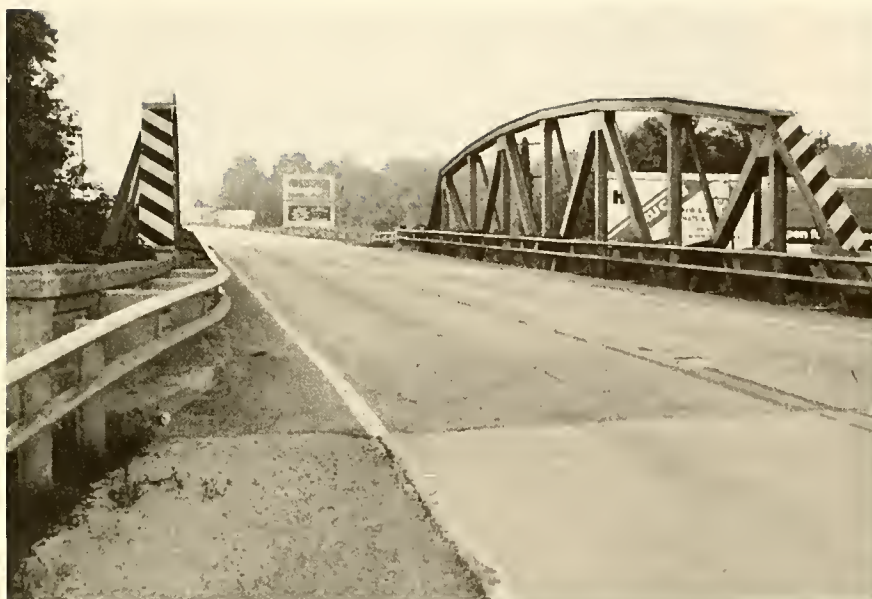
The deck at Bloomington has been in service for five years and for the most part has performed very well. Figure #24 shows the present condition of the Bloomington deck and Figure #25 shows a typical wearing surface joint in the south-bound lane. Most of the problems that have arisen can be traced to poor construction procedures and are not due to the concept used in the design of the precast prestressed deck.

Figure #24. Bloomington Bridge Deck, September, 1974

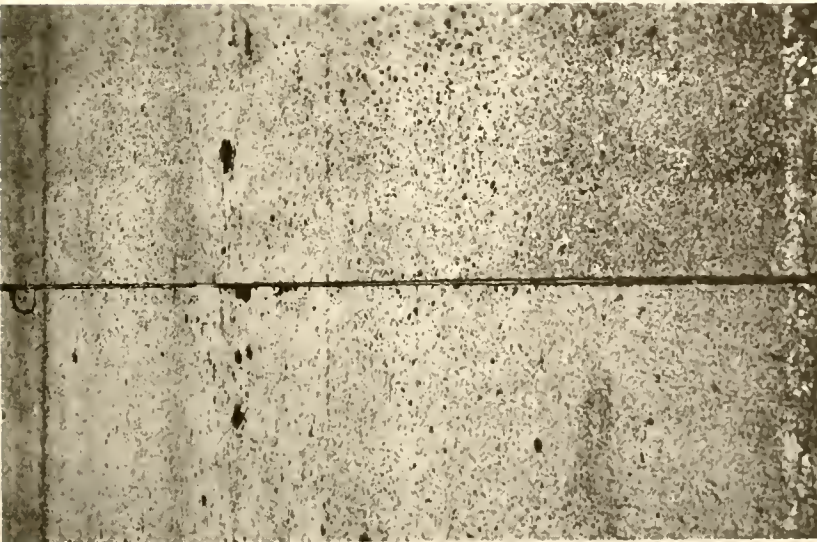
Figure #25. Bloomington Bridge - Typical Wearing Surface Joint in the Southbound Lane. See Figure #27 for Location.

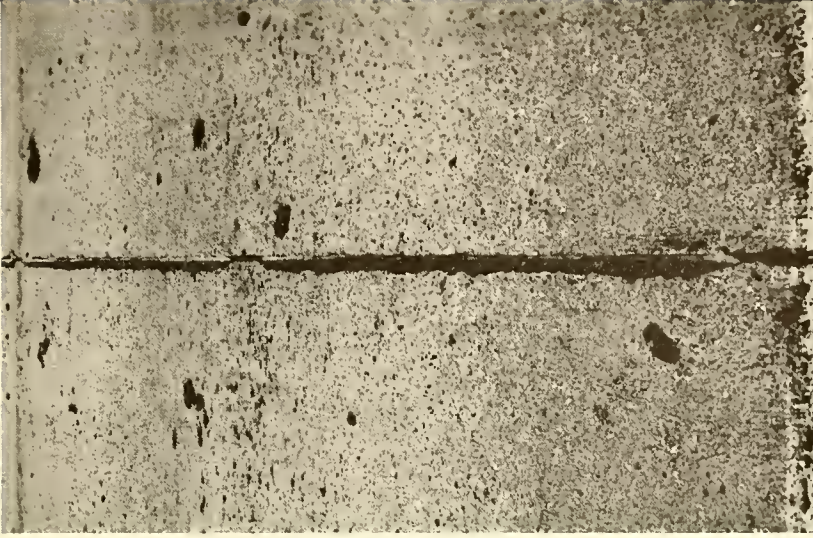
Figure #26. Bloomington Bridge - Repaired Joint in the Southbound Lane. See Figure #27 for Location.

Since all of the sealant repaired and shown on Figure #28 was replaced in late 1970, it is approximately four and one-half years old. DuPont "Imron" was used in all of the repair work and to date has performed satisfactorily, with the exception of minor gravel penetration. A repaired joint can be seen in Figure #26.

of the female joints and after a couple of weeks, traffic pressure worked out the cracked portions of the joint. These joints were repaired by cleaning the joint, forming the joint with Masonite and then filling the broken joint with quick-setting epoxy mortar. The epoxy mortar was allowed to cure and DuPont "Imron" was then used to reseal the joint. One-way traffic was maintained on the bridge during the entire repair operation. One of these repaired joints in the southbound lane can be seen in Figure #26 and its location is shown on Figure #27. All the joints which were repaired at this time are performing satisfactorily.

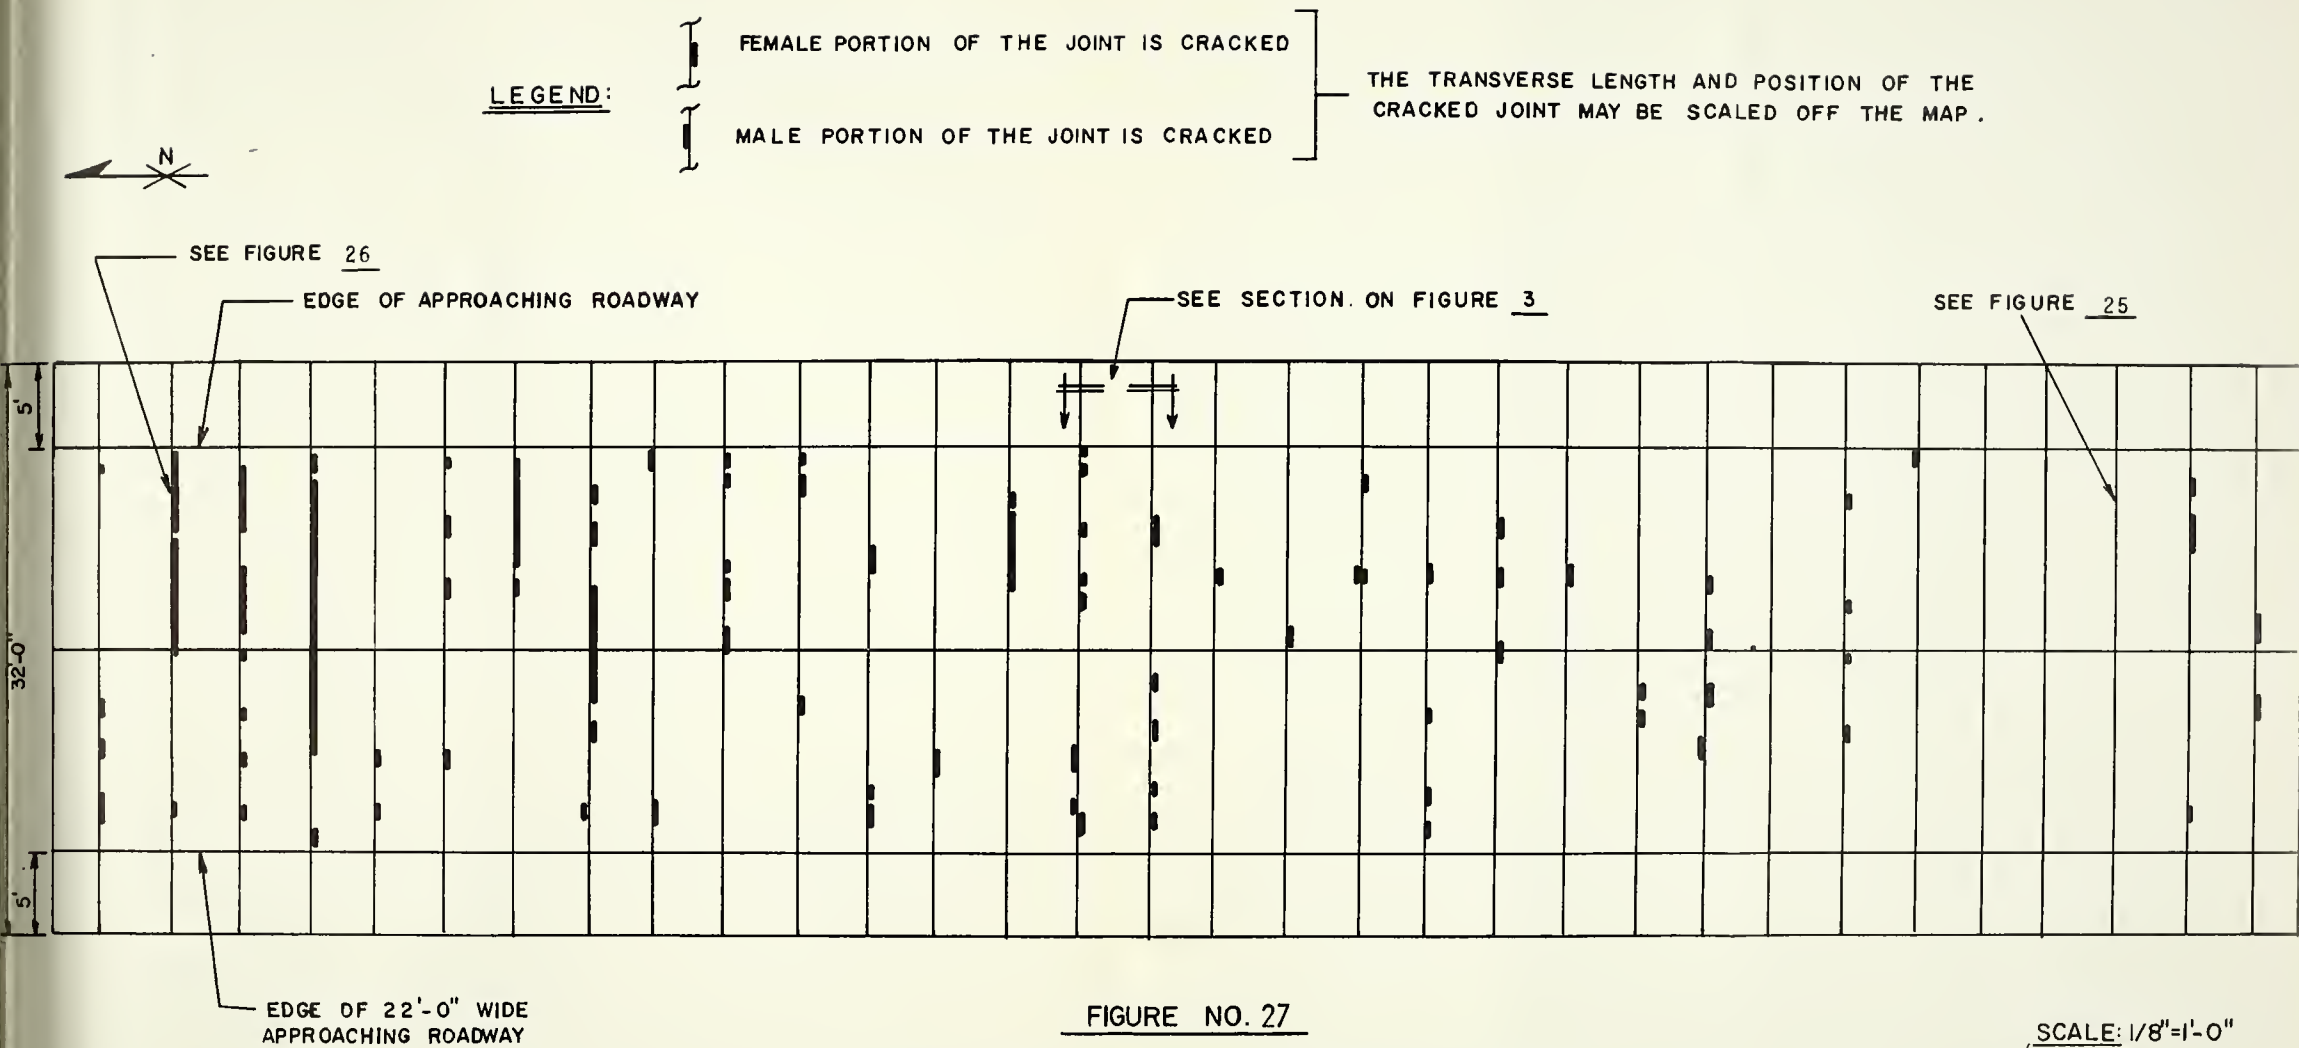
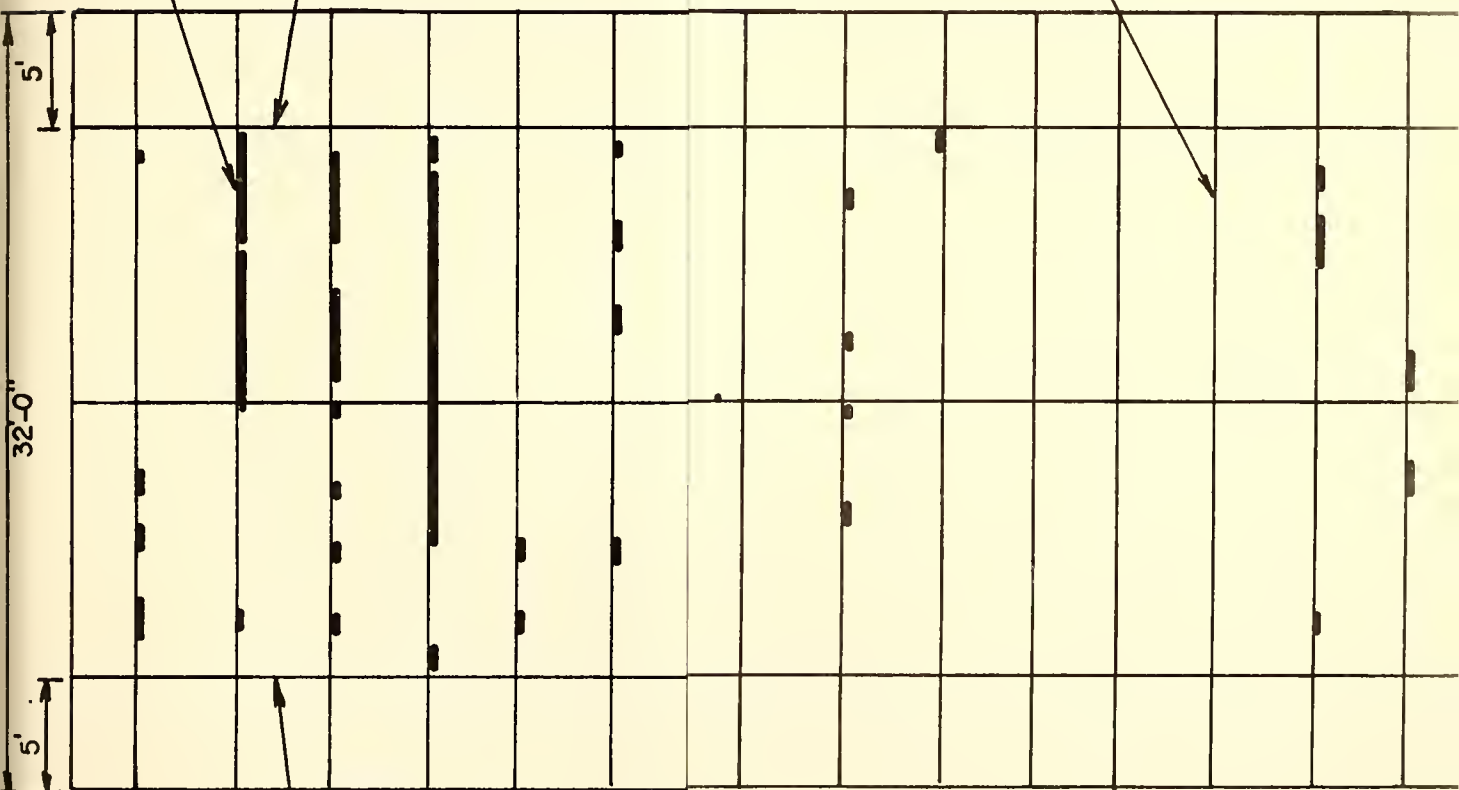
PLAN VIEW OF BLOOMINGTON BRIDGE DECK
MAP OF SPALLED OR CRACKED JOINTS

Immediately after the bridge was open to traffic in 1970, the north approach was resurfaced in order to remove a dip in the pavement. During the resurfacing, a steel wheeled roller was driven a number of times onto both the north and south bound lanes at the north end of the bridge. The high stress from the applied line load cracked a few of the top portions

Figure #27 is a map of all the joints which have cracked or spalled since the bridge was opened to traffic. All of the distressed areas lay in the traffic lanes which tends to indicate that traffic wear is the major cause of the joint cracking or spalling. The two main reasons why the traffic is causing the cracked joints are variations in slab elevations and the use of snow removal equipment. The elevation between slabs vary as much as 1/4" and under repeated wheel load applications, the raised lip of the high slab will either ravel or crack. Usually if the raised edge is the female side of the joint, the female edge will crack and if the raised edge is the male portion it will ravel. The only solution to this problem would be making sure that the slabs were leveled during erection. The other major cause of the cracked joints is the impact load imposed on the slab joints by the blades from the snow removal trucks. Two solutions to this problem might be: (1) using more de-icing chemicals and not using the snow plow blade on the bridge or (2) in the future use a different joint configuration which would eliminate the weak edge inherent in the female portion of the joint.

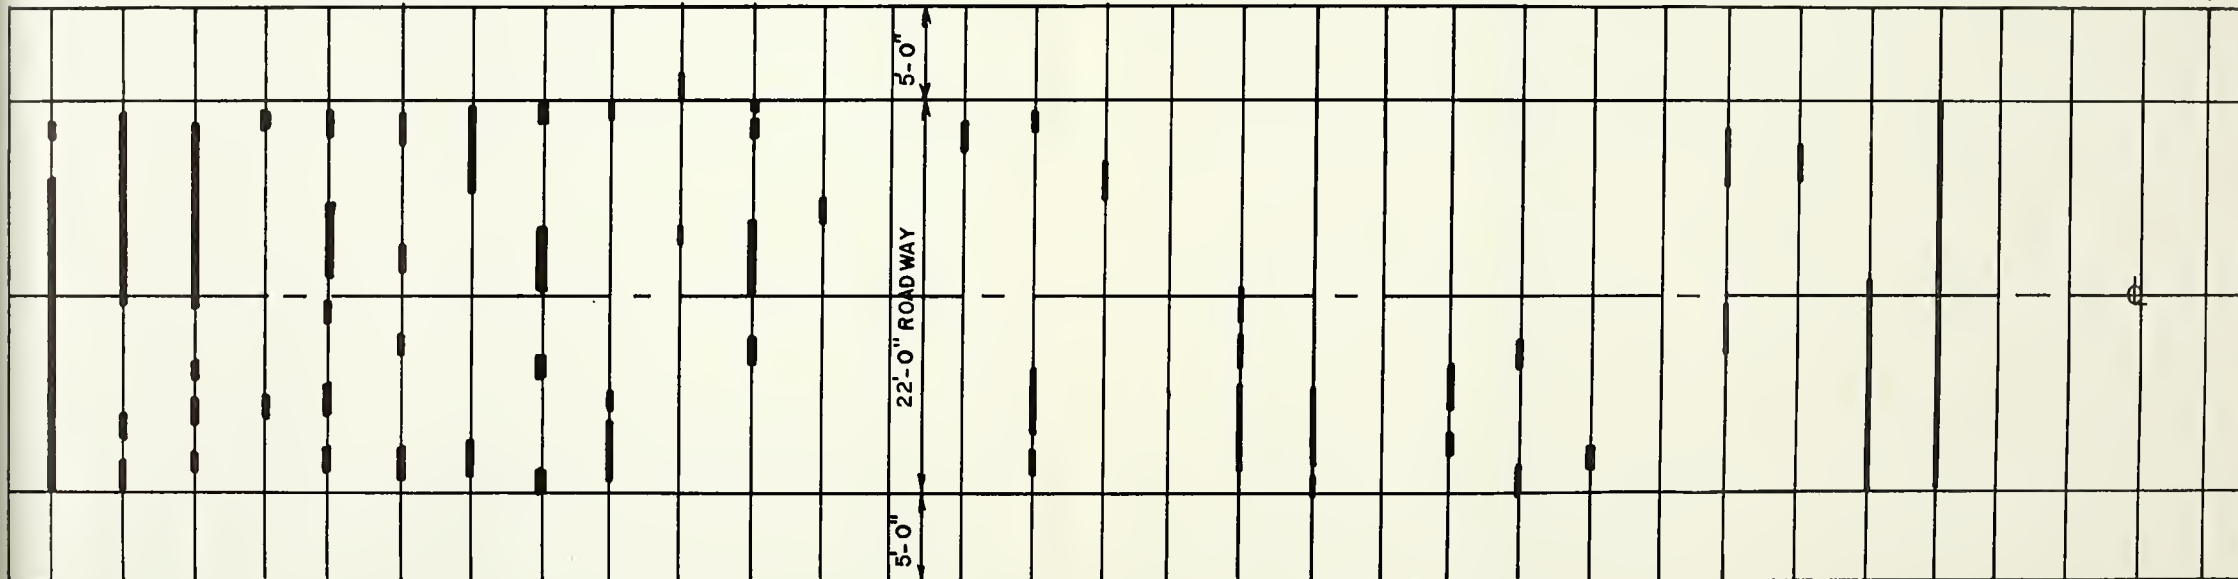
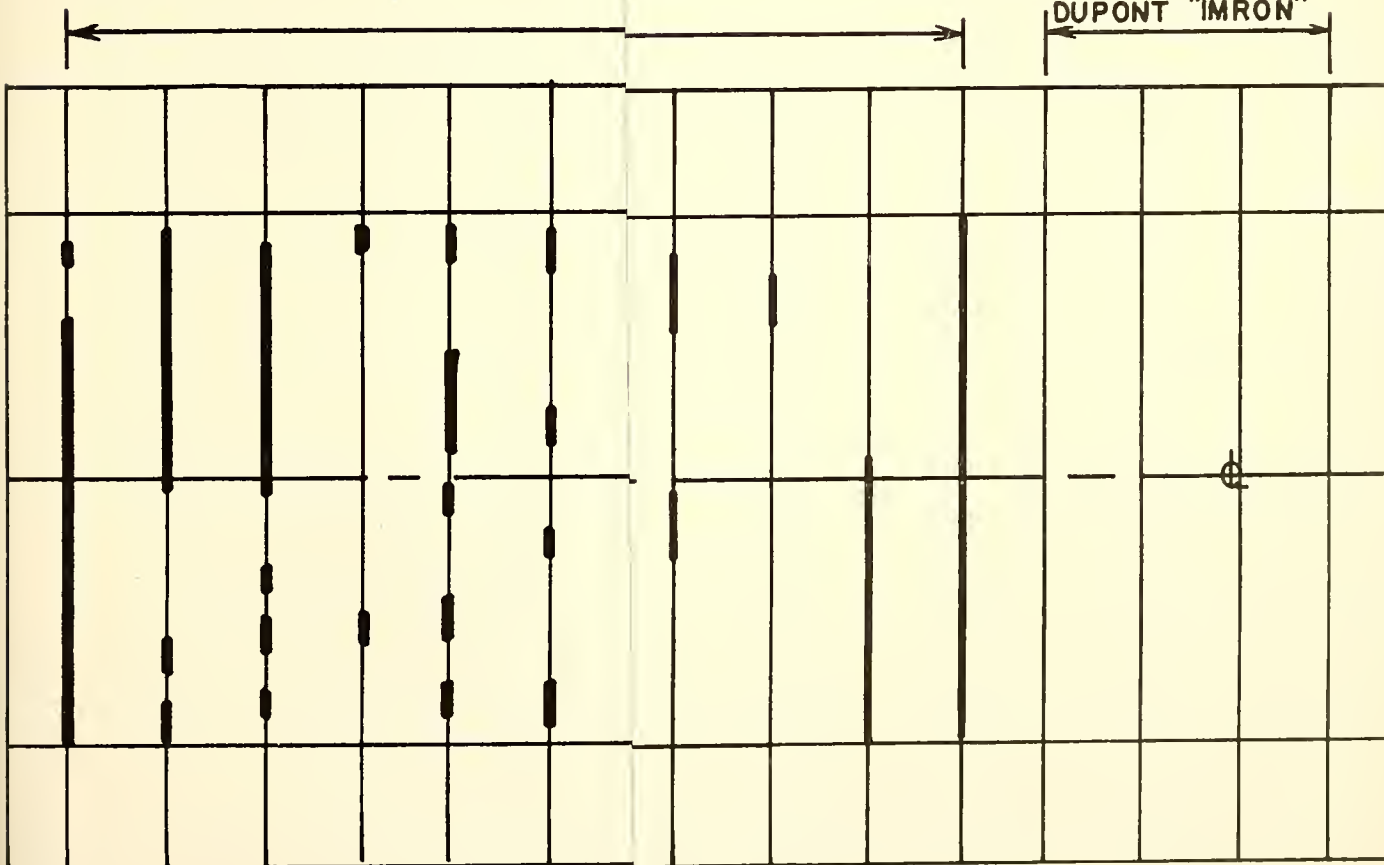
FIGURE NO. 28

will usually work out of the joint under traffic loads. Figure #28 is a map of the areas where the joint sealant has been replaced and shows which areas originally were sealed with the liquid polyurethane sealant and which joints were sealed with DuPont "Imron". In addition to the reasons stated above, the joint sealant also had to be replaced for the following reasons: (1) joint material itself, (2) application techniques which were mentioned earlier and (3) gravel punching the sealant into the joint.

PLAN VIEW OF THE BLOOMINGTON BRIDGE DECK
MAP OF THE AREAS WHERE THE JOINT SEALANT
HAS BEEN REPLACED

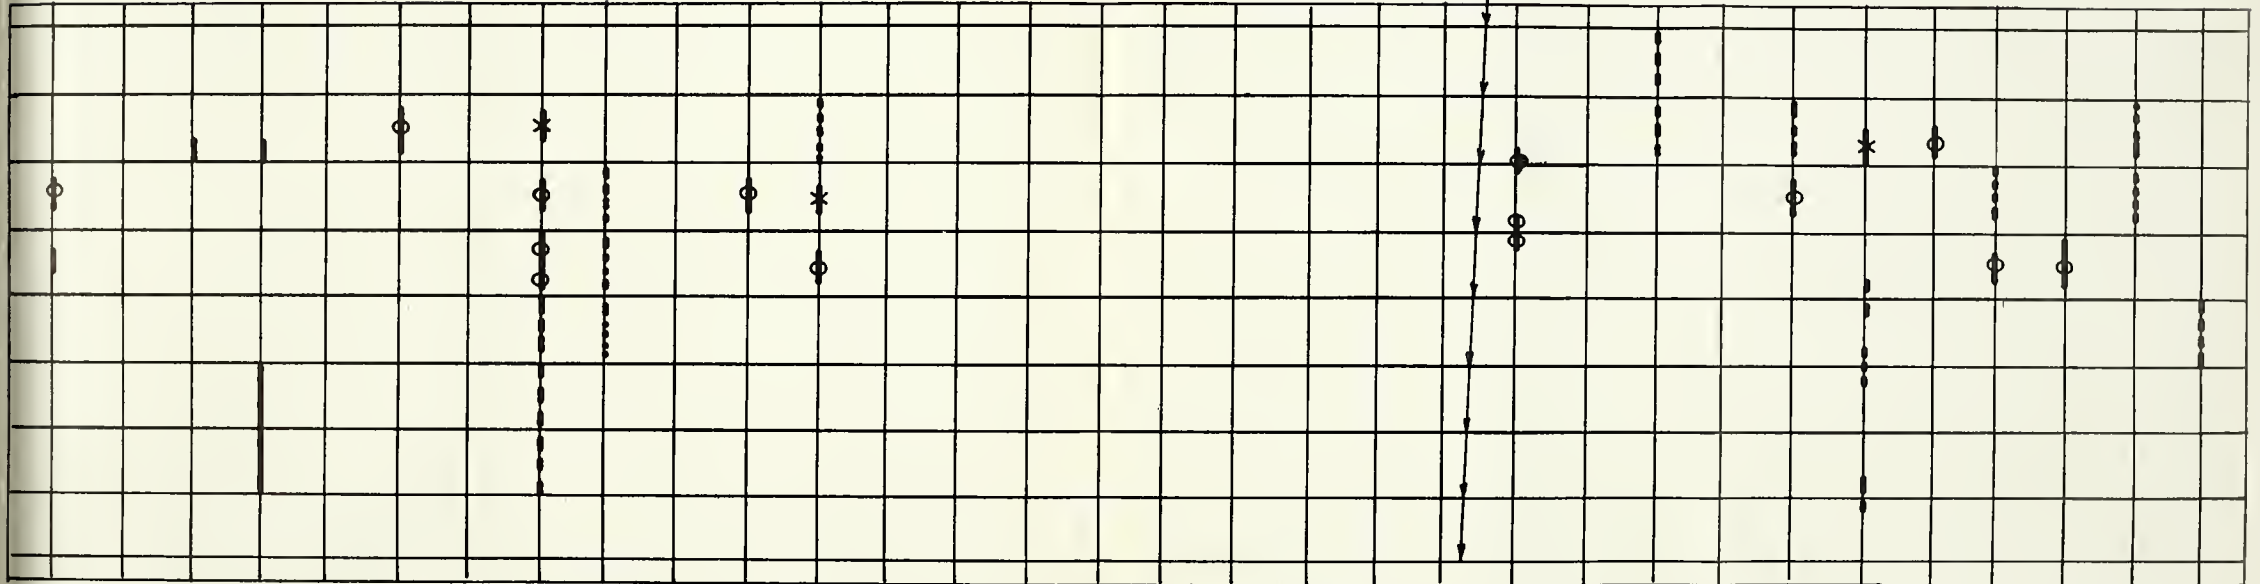
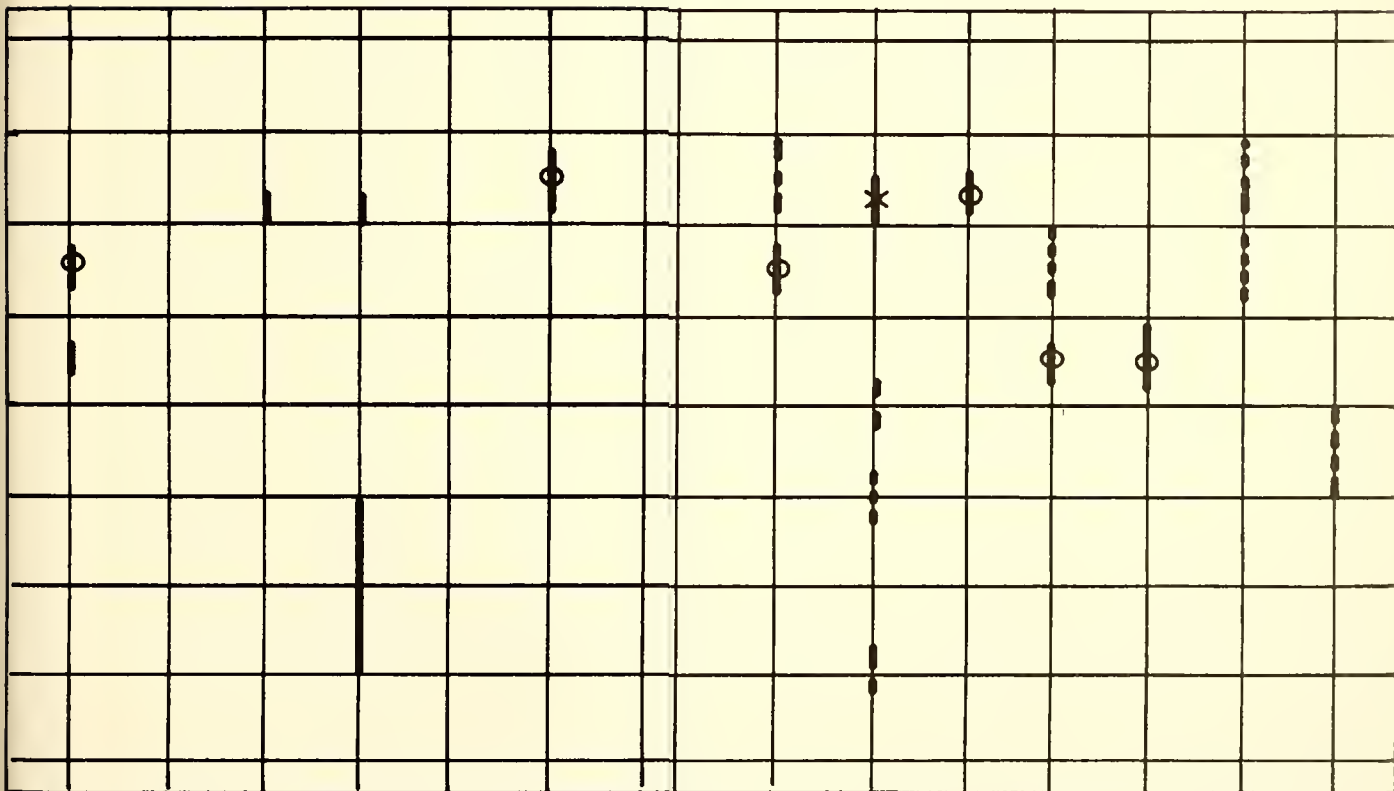
FIGURE NO. 29

Figure #29 shows the areas under the deck where the neoprene sheet has worked down out of the joints. The neoprene sheet was used to minimize stress concentrations between the joints due to minor surface irregularities. The compressive stress in the neoprene was relatively high in the areas where it has worked out of the joints. This high stress was due to a major irregularity in the surface of the joint which was in turn caused by warping of the forms where the slabs were poured. In order to relieve this high stress, the neoprene works out the joint under the repeated traffic load.

PLAN VIEW OF THE BLOOMINGTON BRIDGE DECK
MAP OF THE BOTTOM SIDE OF THE JOINTS WHERE
THE NEOPRENE SHEET HAS WORKED OUT OF THE JOINT

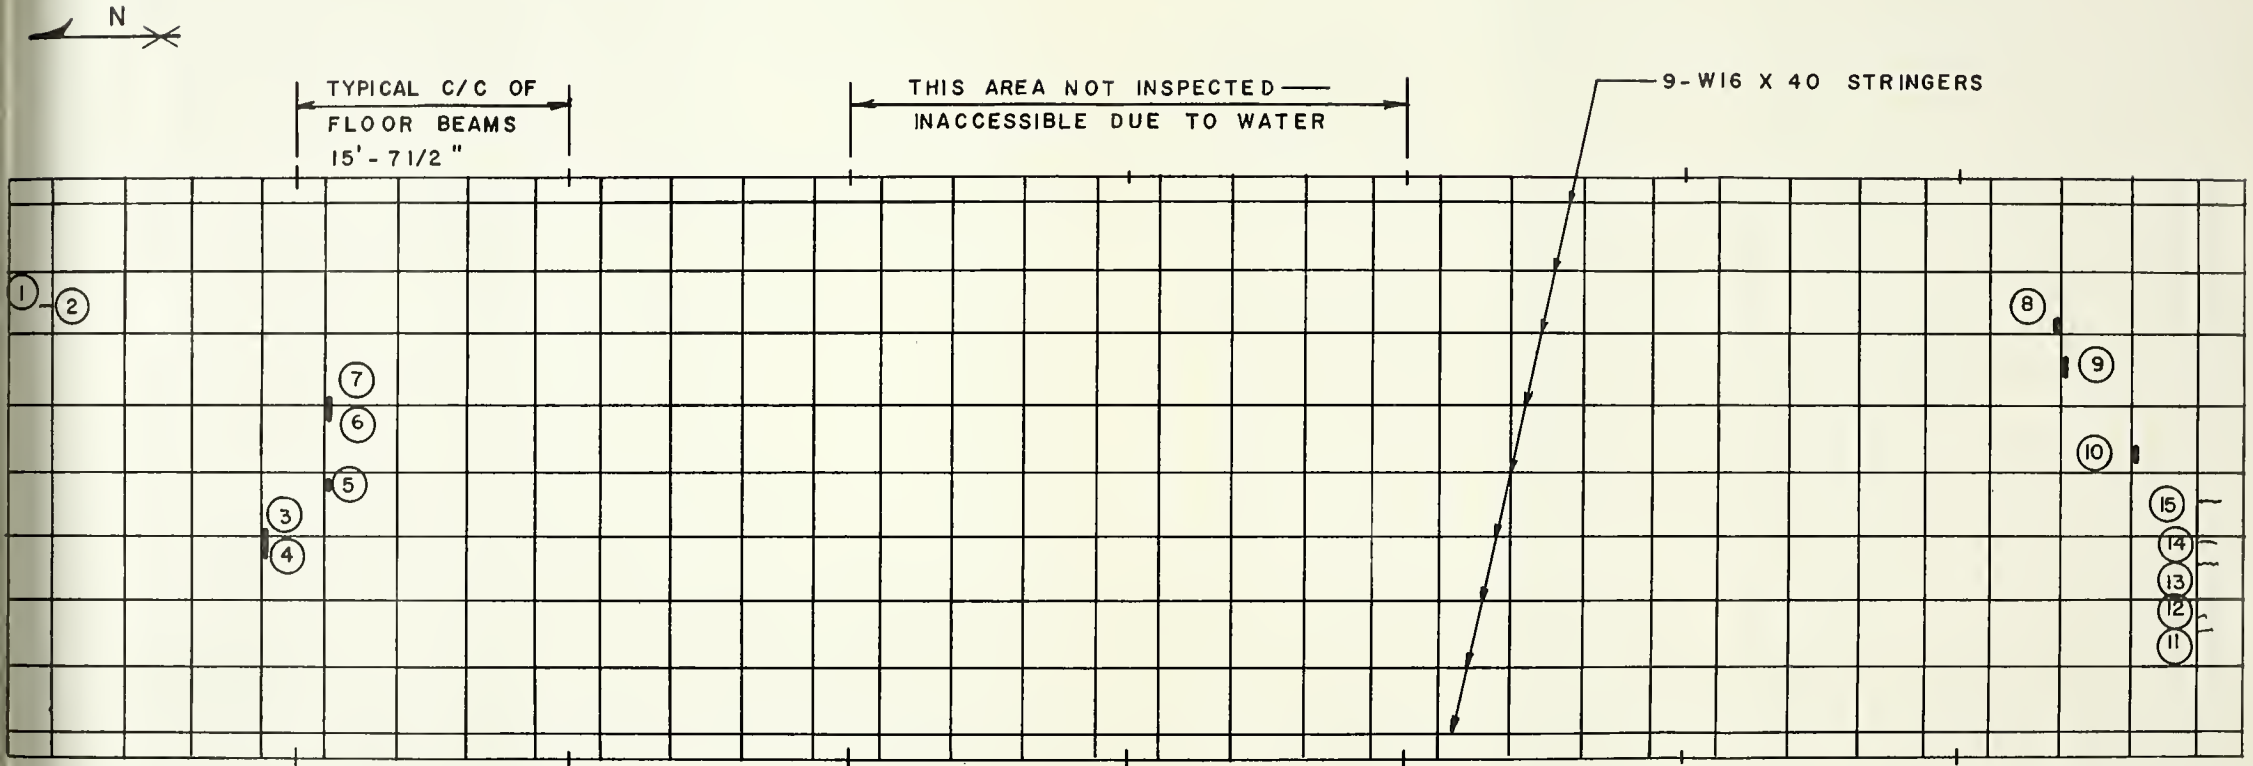
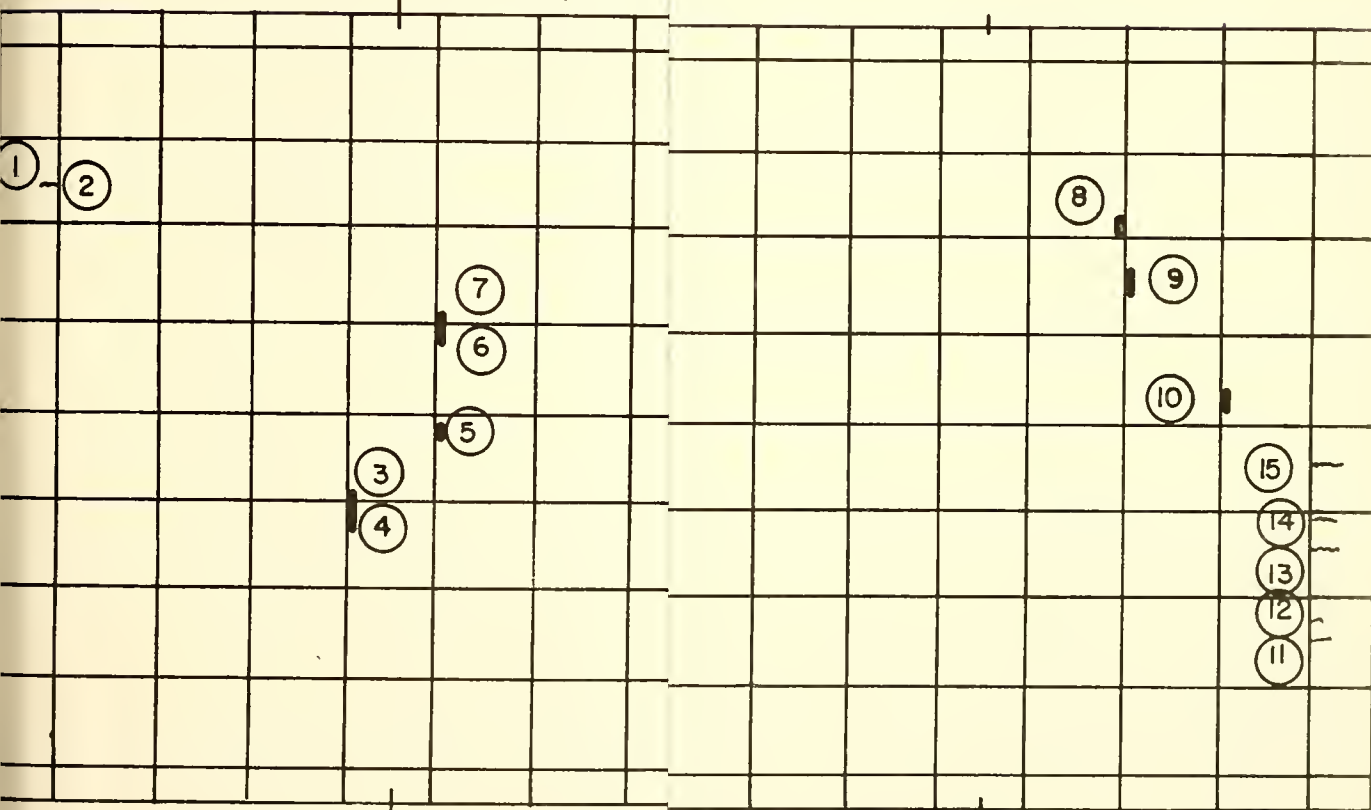
FIGURE NO. 30

Figure #30 is a map of the other distressed areas on the underside of the slabs and Table 2 describes the condition of each of the numbered areas on the map. The probable cause for the broken clips and bolt in area ① was the initial lack of bearing between the slab and the stringer. This lack of bearing was noticed after the bridge was opened to traffic and shims were immediately driven between the slab stringer and precast slab, but the traffic load kept working the shims back out of the void (See Figure #31).

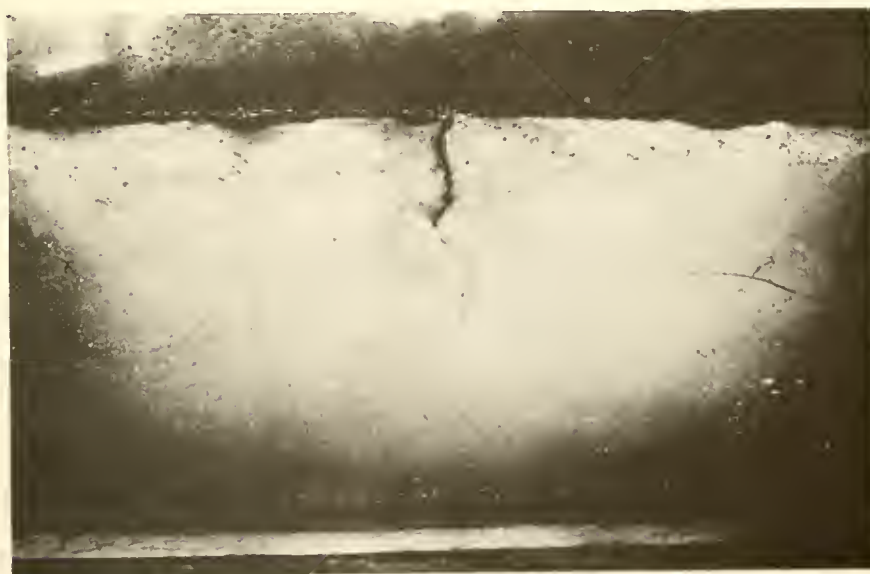
Figure #32. Area ② - 8" longitudinal surface crack (See Figure #30 and Table 2)

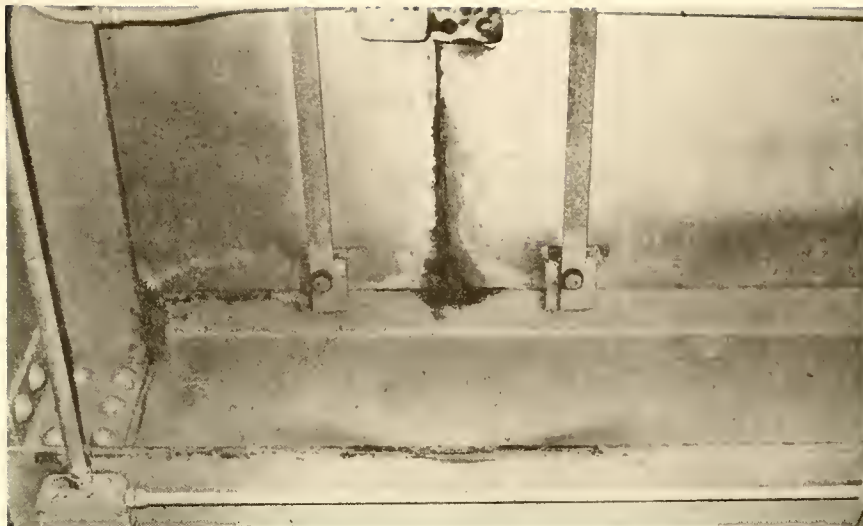
Figure #33. Area ⑤ - (Typical of Areas 3 thru 7) Cracked female joint at the stringer bearing point. (See Figure #30 and Table 2).

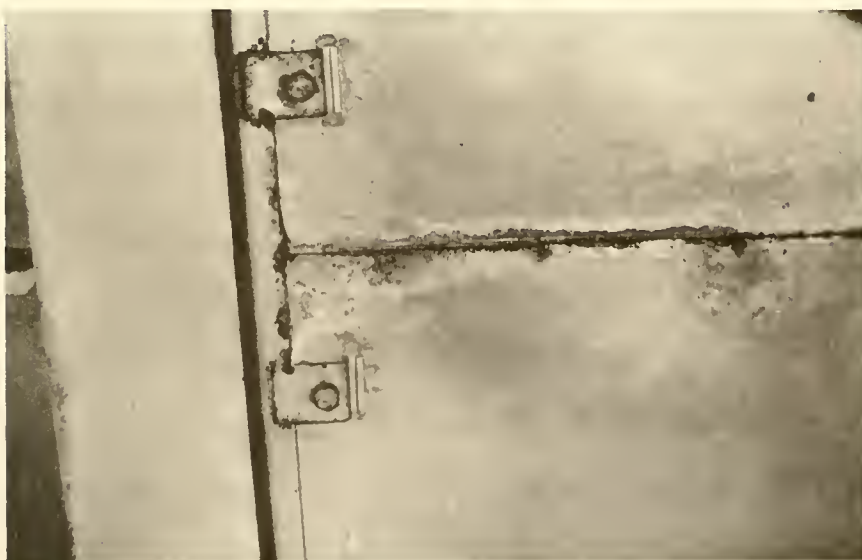
Figure #34. Area ⑧ - Spalled male portion of the joint--2"x2"x1/4" deep (See Figure #30 and Table 2).

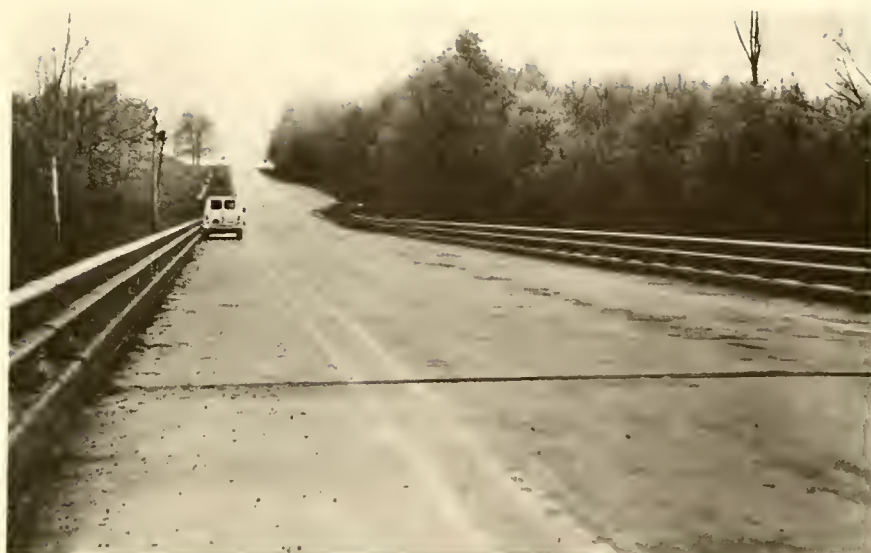
Figure #35. Knightstown Bridge Deck, September, 1974

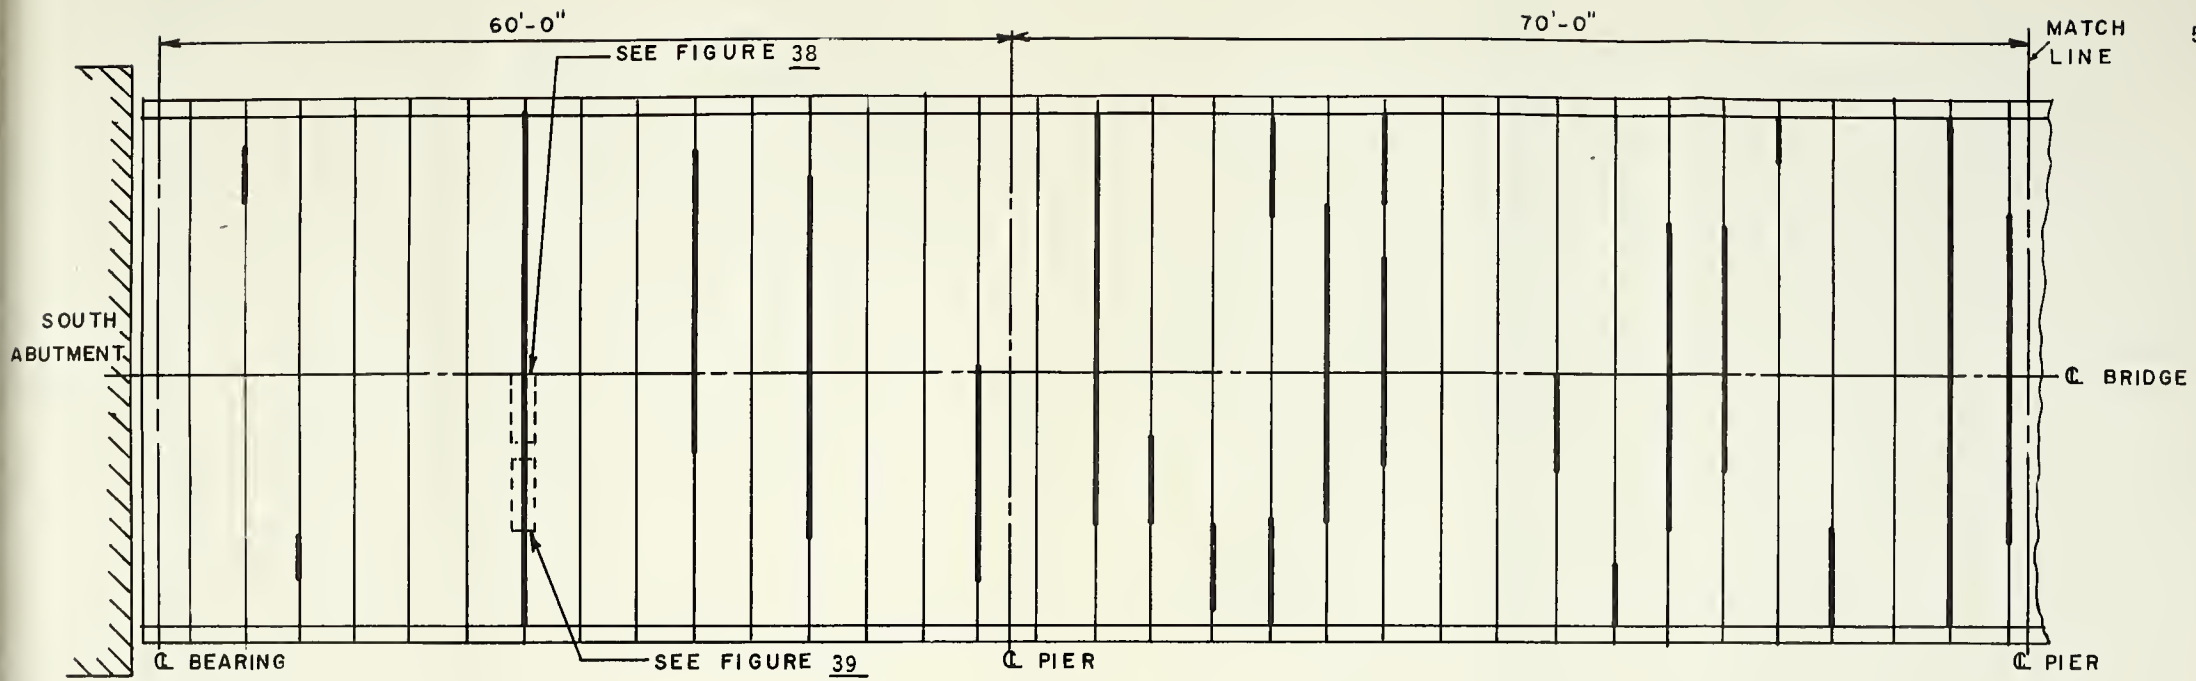
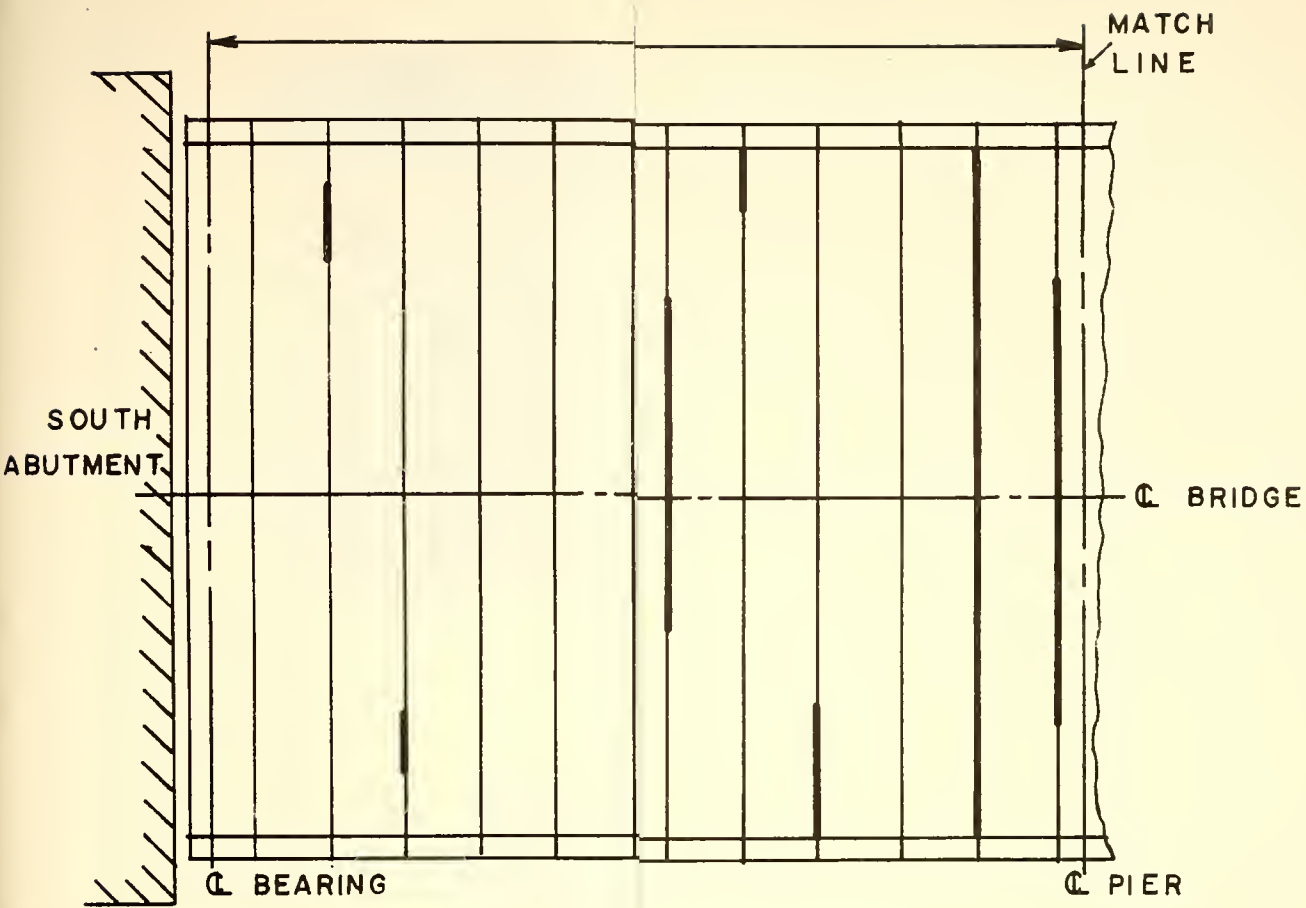
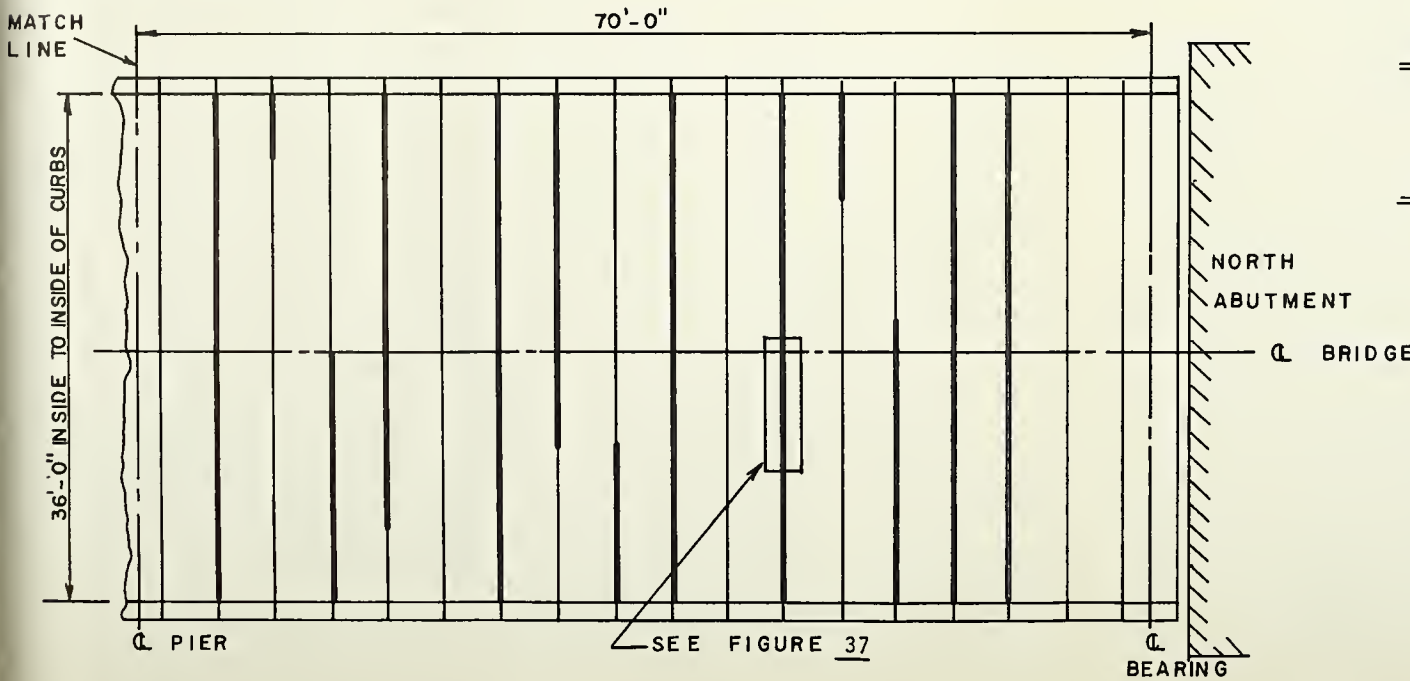
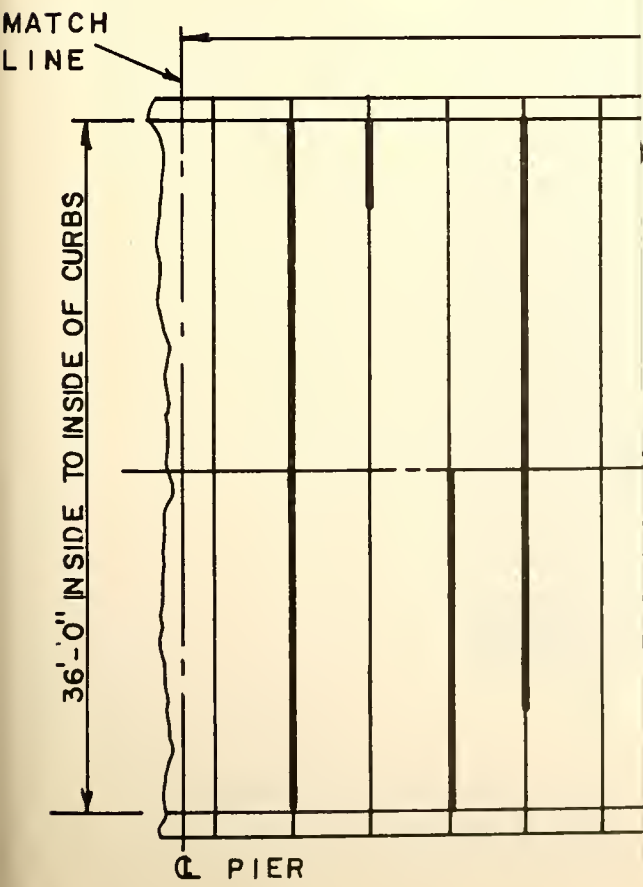
FIGURE NO. 36
PLAN VIEW OF THE KNIGHTSTOWN BRIDGE
MAP SHOWING AREAS WHERE THE WIDTH AT
THE TOP OF THE JOINT IS LESS
THAN 1/8 INCH.

AT THE TOP OF THE JOINT IS
THAN 1/8". TRANSVERSE LENGTH
BE SCALED OFF MAP.

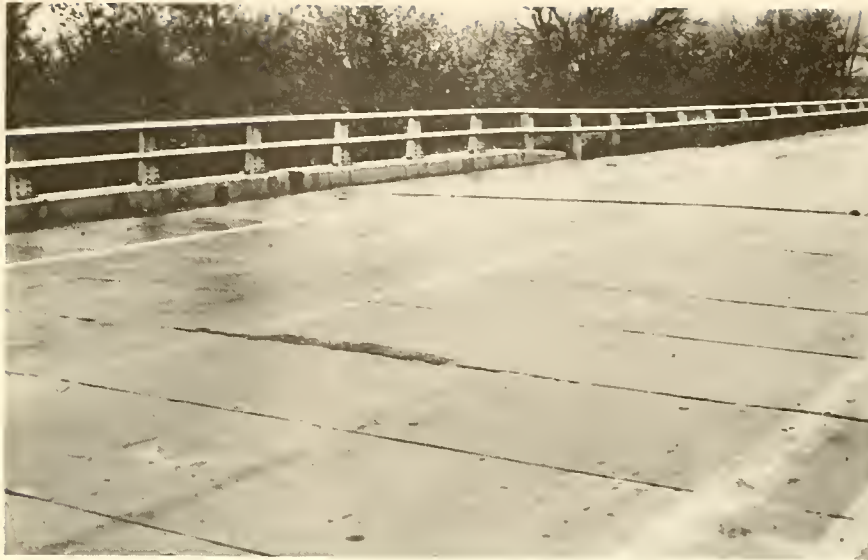
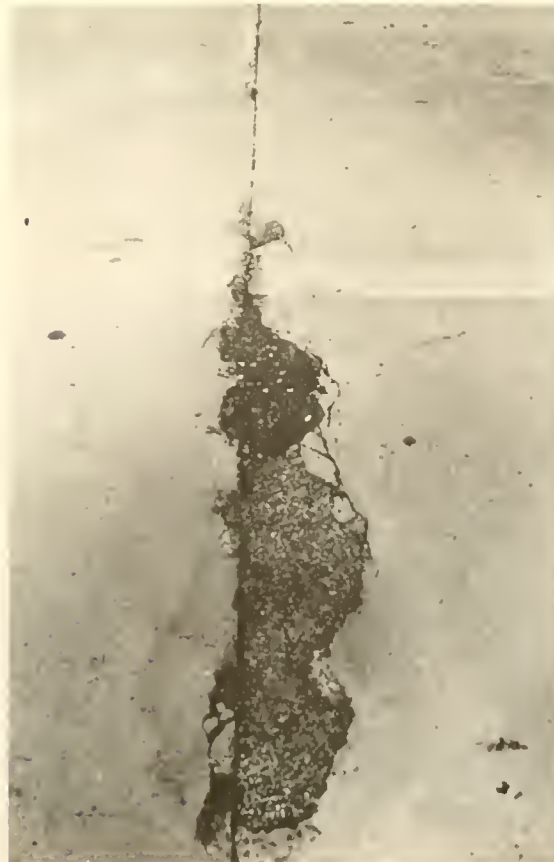
Figure 37. Knightstown Bridge - Progressive Failure of the Male Portion of the Joint. See Figure #36 for Location.

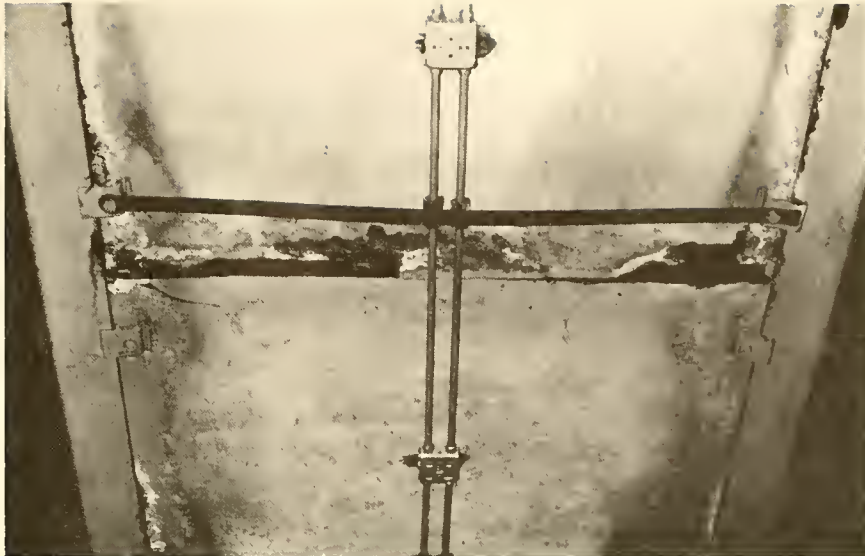
The only other problem observed at Knightstown was that concrete patches applied in the precaster's yard deteriorated after about one year. The photographs in Figures #38 and 39 show patched female joints on the underside of the slab where the patch has deteriorated or has fallen out of the joint. Also there are only a few places where the neoprene has started to work out of the joint.

Figure #38. Knightstown Bridge - A Patch Applied in the Precaster's Yard Which Has Failed. See Figure #36 for Location.

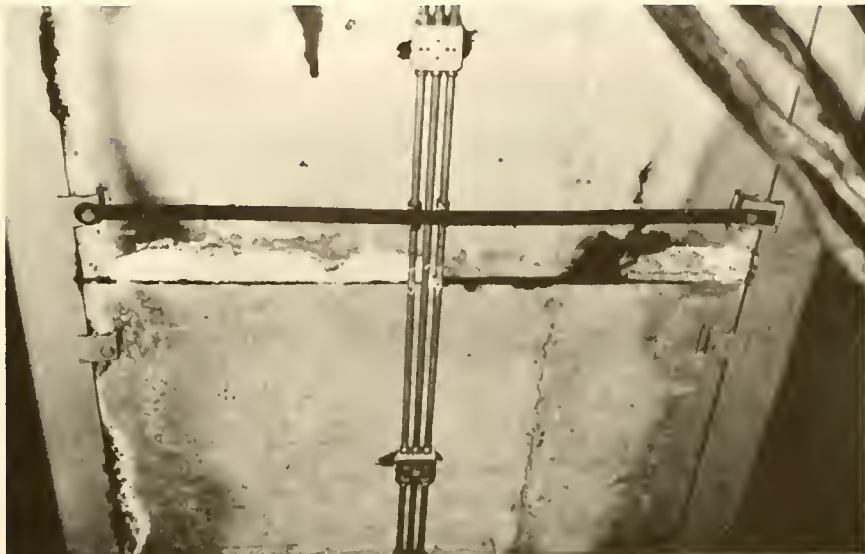
Figure #39. Knightstown Bridge - A Patch Applied in the Precaster's Yard Which Has Failed. See Figure #36 for Location.
